# Manhole Inspection Summary

Manhole # S25MM\_028MH

Insp Date: **7/31/07 9:53 AM**

**Location** Address: **2200 LINDEN AVE**

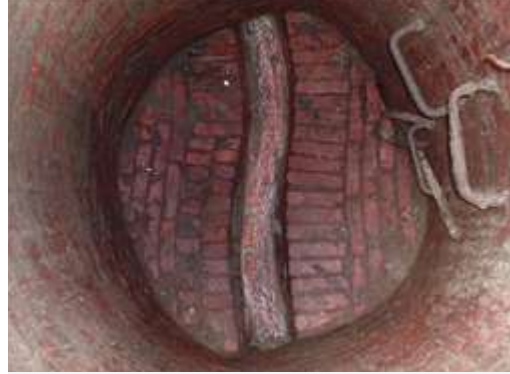
Top View

Corroded and missing steps. Bench debris.

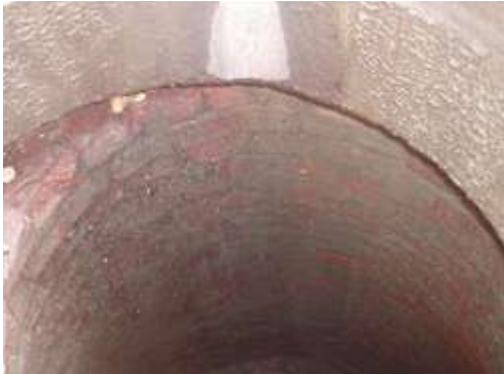
Defect

Frame leaks. Frame offset. Adjustment deterioration and infiltration. Corbel and Barrel infiltration - other side.

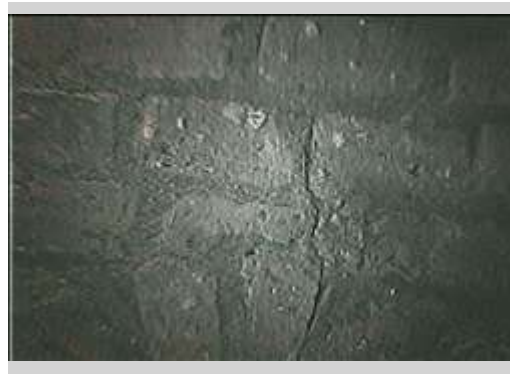
Defect

Barrel crack and infiltration.

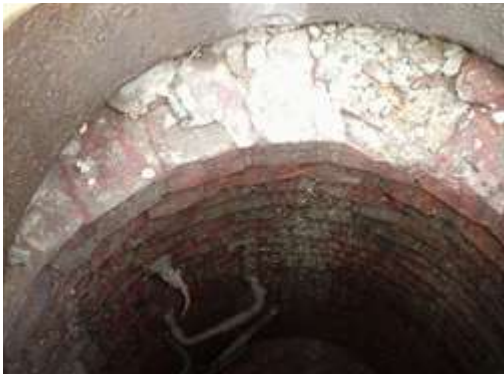
Defect

Frame leaks. Frame offset. Adjustment deterioration and infiltration. Corbel and Barrel infiltration.

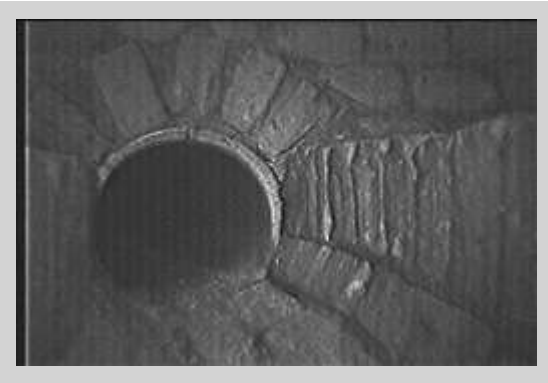
### 8 in. Circular Gravity Sewer Pipe Out @ 12 O'Clock

Channel deterioration.

Infiltration: **Evidence** Pipe Seal Cond: **Cracked**

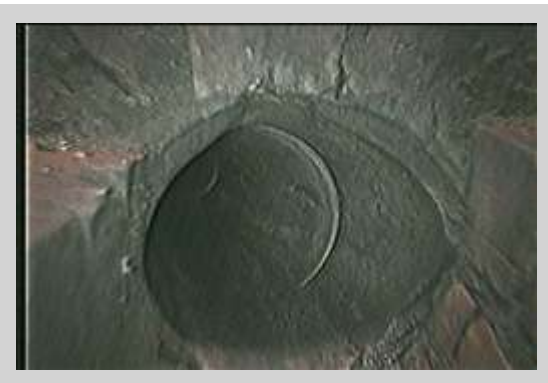
### 8 in. Circular Gravity Sewer Pipe In @ 6 O'Clock

Infiltration: **Evidence** Pipe Seal Cond: **Broken**
